# Manhole Inspection Summary

Manhole # S41KK\_010MH

Insp Date: **9/1/09 11:26 AM**

**Location** Address: **181 HARFORD AVE**

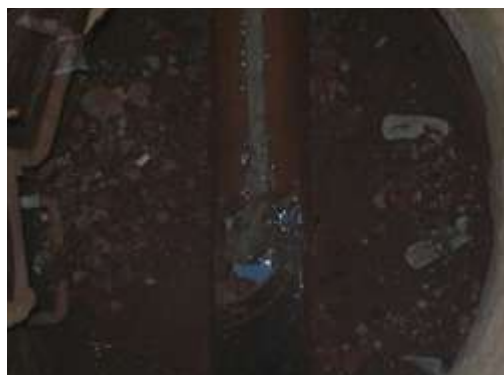
Defect 3

Condition: ☐ Sound ☐ Cracked ☐ Root Intrusion ☐ Deteriorated ☐ Leaks ☒ **Debris**

DEBRIS ON BENCH AND CHANNEL

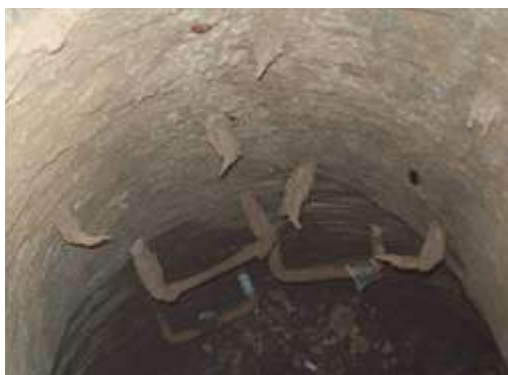
Defect 2

**Steps** Count: **6** Missing: **3** ☒ **Corroded**

CORROED STEPS

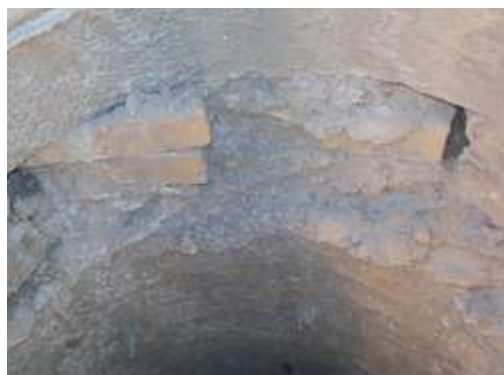
Defect 1

Condition: ☐ Sound ☐ Cracked ☐ Root Intrusion ☐ Loose Brick ☒ **Deteriorated**

DETERIATED CHIMNEY

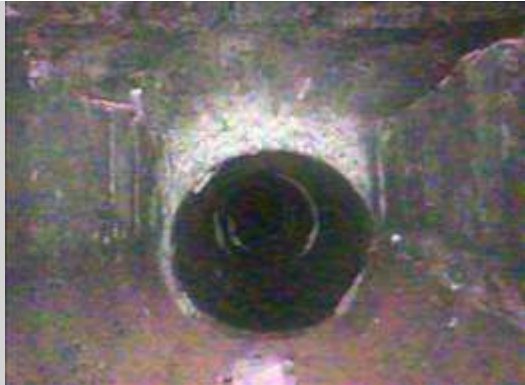
12 O'Clock Outflow

8 in. Circular Gravity Sewer  
Pipe Out @ 12 O'Clock

Pipe Height: (in.) Direct  
Pipe Material: **Clay** ☐ Pipe Lined  
Invert Depth: **10.80** (ft.) Flow Characteristics: **Slow**  
Deposits: ☒ None ☐ Mud ☐ Sludge ☐ Debris ☐ Grease  
Silt Depth: (in.) Deposits Extent:  
Infiltration: **None** Pipe Seal Cond: **Sound**

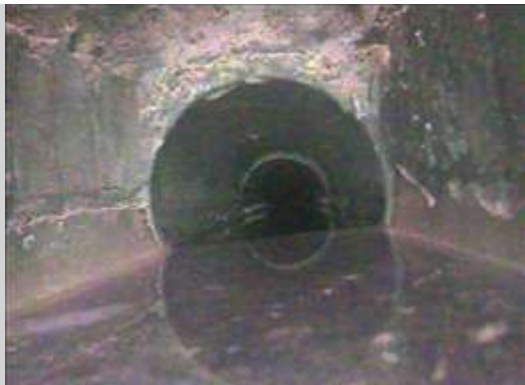
6 O'Clock Inflow

8 in. Circular Gravity Sewer  
Pipe In @ 6 O'Clock

Pipe Height: (in.) Direct  
Pipe Material: **Clay** ☐ Pipe Lined  
Invert Depth: **10.60** (ft.) Flow Characteristics: **Slow**  
Deposits: ☒ None ☐ Mud ☐ Sludge ☐ Debris ☐ Grease  
Silt Depth: (in.) Deposits Extent:  
Infiltration: **None** Pipe Seal Cond: **Sound**
